Integral LED Luminaire vs LED Retrofit Kit

LED Retrofit Safety Standards

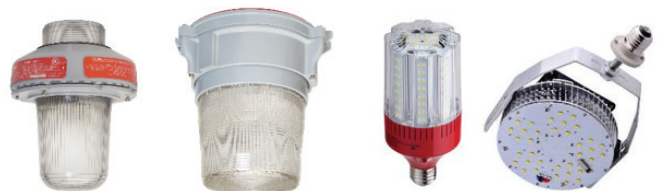
Integrated LED Luminaires

LED Retrofit Kit

An Integral LED Luminaire replaces an existing installed legacy light fixture and is engineered around the unique needs of LED technology. Delivered ready to install, it is a fully contained LED luminaire assembly including the external environmental enclosure (housing and globe assembly), electrical connectors and wiring, internal LED power supply (driver), and LED light emitters typically soldered to a circuit board (LED array).

In contrast, an LED Retrofit Kit modifies an existing installed legacy light fixture from typically fluorescent or HID technology to LED technology, without replacing the legacy light fixture's enclosure. In this case the legacy lamp is replaced with an LED light subassembly or "LED lamp" that directly screws into the legacy lamp socket. The LED lamp includes the LED power supply and LED array(s). Some degree of wiring reconfiguration may be needed for the electrical supply to the socket within the legacy fixture to accommodate the electrical requirements of the LED lamp.

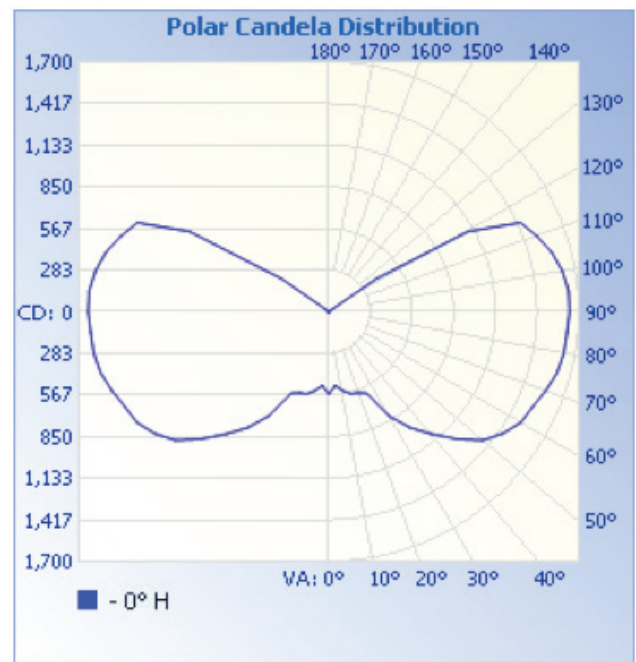
Figure 2 Polar Candela of Appleton 150W HPS

This can be seen in the polar candela distribution and zonal lumen summary for a 150W HPS Mercmaster III luminaire, shown in Figure 2 and Table 5. As indicated in the zonal lumen summary, 38.6% of the light output is lost

to up-light, with only 24.7% of the total light output landing within the 0-60° beam. Furthermore, nearly 37% of the light output of this luminaire falls between 60 and 90°; the primary area where glare is produced.

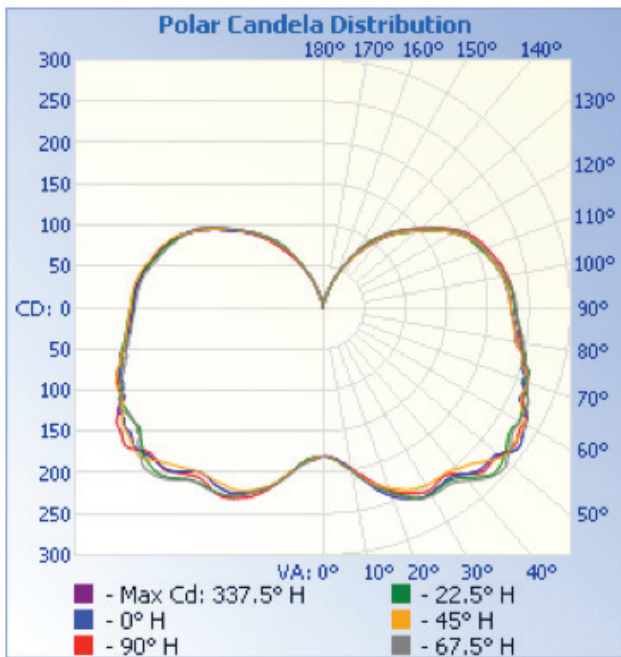
Figure 3 Polar Candela with LED Retrofit Lamp

LED retrofit lamps, commonly called “corn cob lights,” produce an omni-directional spread, similar to traditional lamps. As shown in Figure 3 and Table 6, the distribution of the light is similar, although the total luminous flux (light output) is significantly less. This results in an unfocused, 360° distribution, losing over 35% of the light produced above the 90° horizontal plane.

in the 60-90° zonal range, increasing the incidence of discomfort glare. At 25°C (77°F) only 1,614 lumens are directed downward, with a mere 823 lumens in the 60° beam angle.

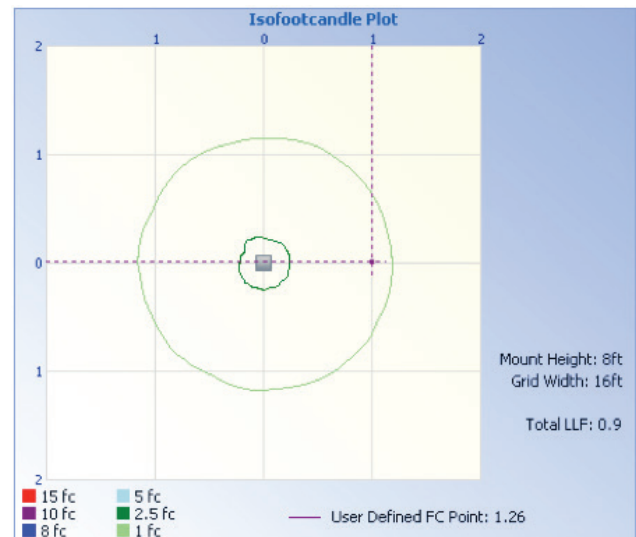
Figure 7 Plot with LED Retrofit Lamp

As shown in the simulated plot, the 150W HPS luminaire (without a reflector) would deliver an approximately 20 foot diameter circle with illuminance levels of 5 foot-candles or above. Comparatively, the resultant illuminance with the retrofit lamp is shown in Figure 7. This solution produces a maximum of 2.5 foot-candles of light directly under

the luminaire. While this illuminance is 50% below the requirement, the performance eight feet out is significantly worse; delivering a mere 1.26 foot-candles of light.
